Name Of Dam: BROAD RUN DAM
Location: PRINCE WILLIAM COUNTY
Inventory Number: VA. 15302

PHASE I INSPECTION REPORT

Broad Run Dam. Inventory Number:
VA-15302. Prince William County. Virginia.
Phase I Inspection Report.

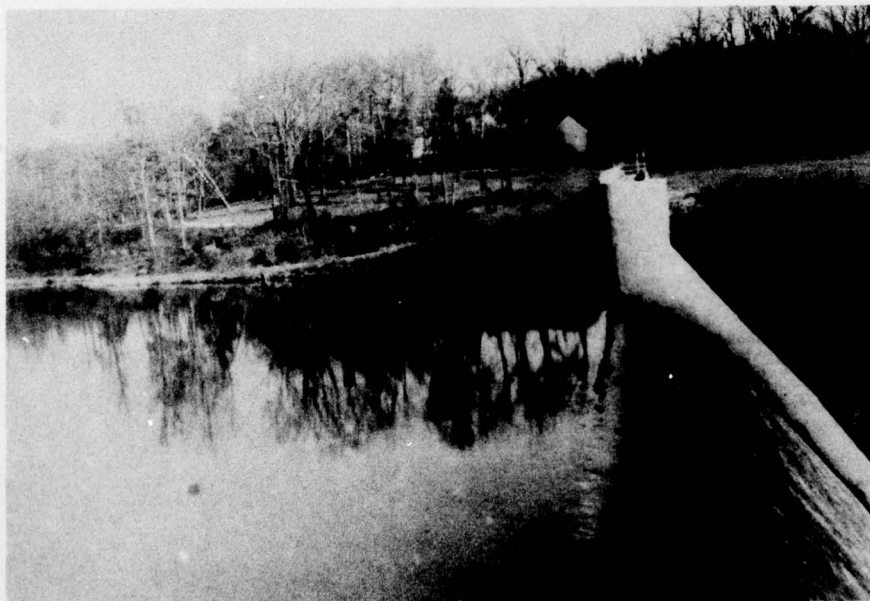
PHOTOGRAPH NO. 2
Principal Spillway Crest

2. Stains were showing through the thin film of water going over the spillway. These stains are about 44 feet from the left end of the principal spillway and 10 to 15 feet below the crest.

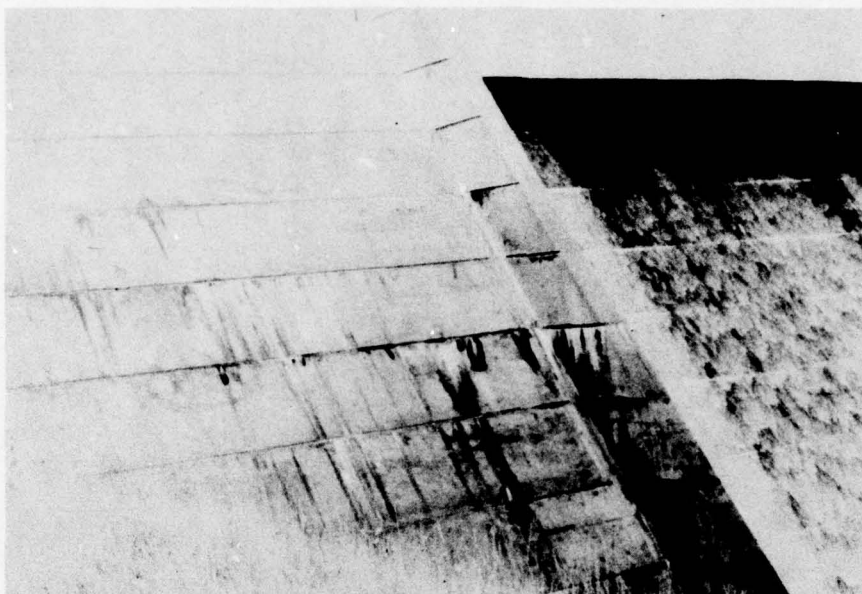
PHOTOGRAPH NO. 3
Spillway & adjacent Wall

3. The left wall has hairline cracks showing calcium deposits. The crack is located at about elevation 250 and about 10 feet left of the principal spillway.

VISUAL EXAMINATION OF	OBSERVATIONS	REMARKS OR RECOMMENDATIONS
SURFACE CRACKS CONCRETE SURFACES	Hairline crack 5' vertical approximately 10' left of left end of spillway in concrete wall shows white deposits.	
STRUCTURAL CRACKING	None visible.	
VERTICAL AND HORIZONTAL ALIGNMENT	Horizontal ok. Owner representative reported that water goes over crest of principal spillway at right end of spillway before covering the entire length of spillway crest. See Photo No. 2. This could indicate settlement at left end of spillway, or crest was not level when constructed.	
MONOLITH JOINTS	No visible seepage.	
CONSTRUCTION JOINTS	44 ft. right from left end of spillway, about 5 feet below crest, was wet for a length of 60 feet and showed calcium deposits. Owner reported this was happening for several years. The water enters at a horizontal construction joint on the downstream side of passageway.

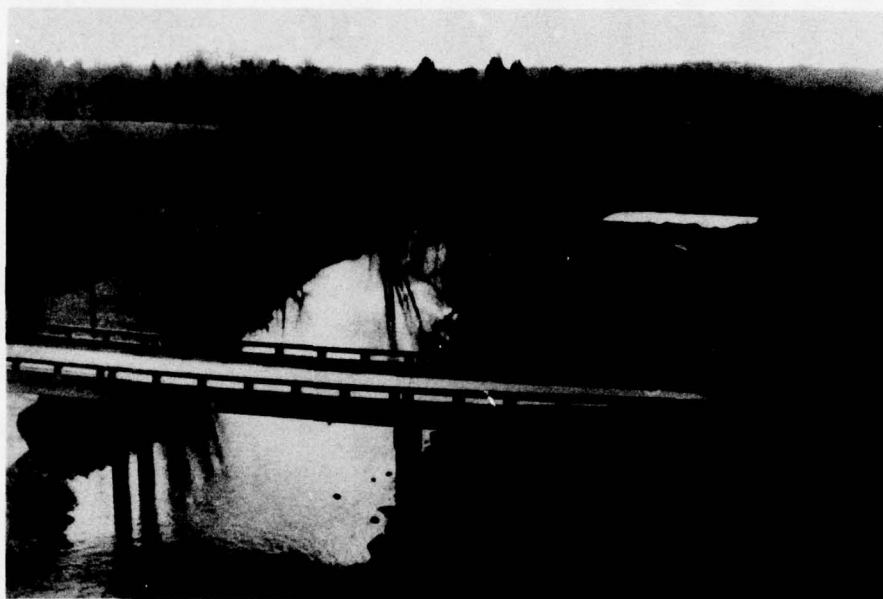
PHOTOGRAPH NO. 5
Downstream Channel

VISUAL EXAMINATION OF	OBSERVATIONS	REMARKS OR RECOMMENDATIONS
CONCRETE WEIR	Ogee principal spillway.	
APPROACH CHANNEL	Not visible.	
DISCHARGE CHANNEL	Concrete spillway, ogee type to riprap channel. See outlet works outlet channel.	
BRIDGE AND PIERS	3-span 2-lane structure 200' downstream from dam. With stood 1972 flood. Washed rip-rap away from bridge piers. No bridge over principal spillway.
